## **APPENDIX E**

### **Site Visit Documentation**

H&A File No.: 33794-000 Date of Visit & Interview: 11-13 September 2006

Site Name and Address: Burgess Pulp Mill, Berlin, New Hampshire

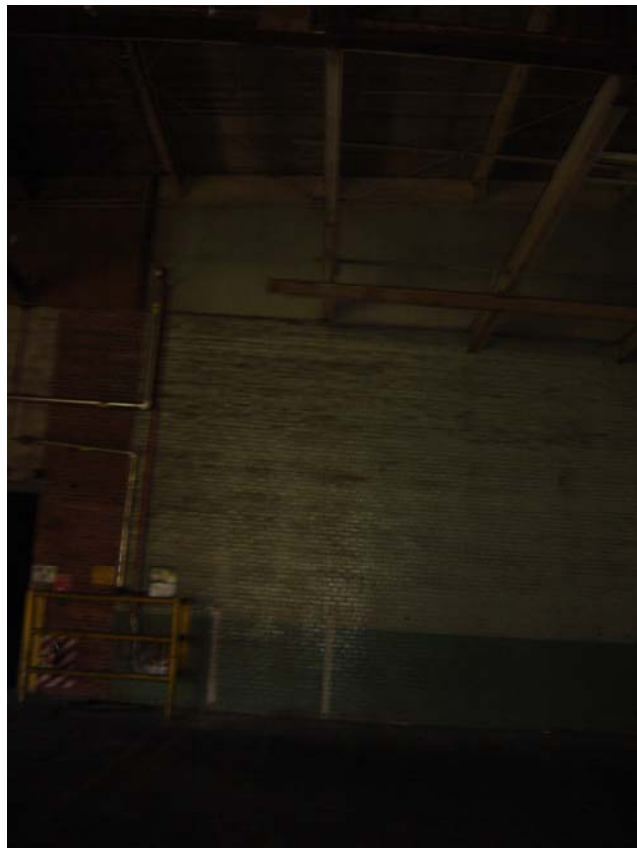
Baled Pulp Storage Back High Transite

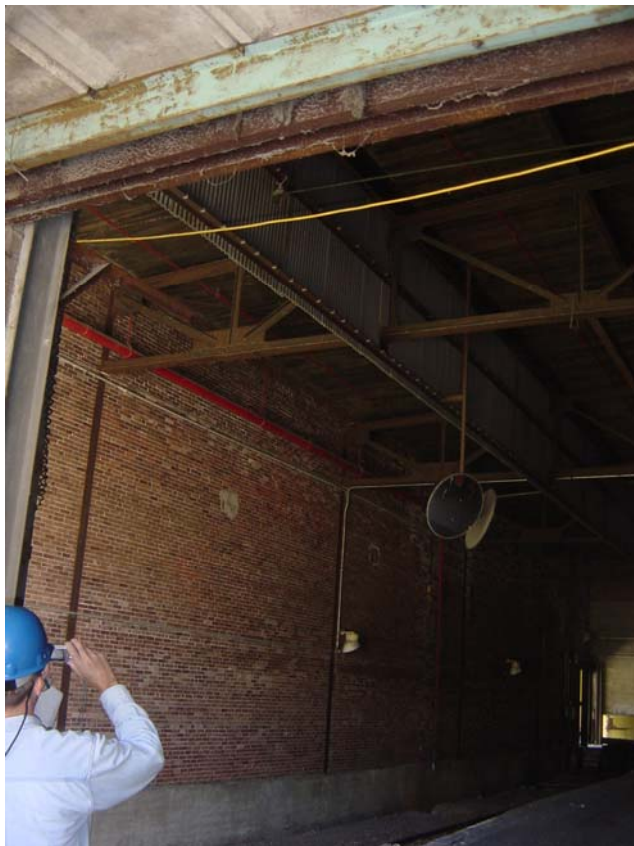
Baled Pulp Storage by RR Tr 2 High Transite

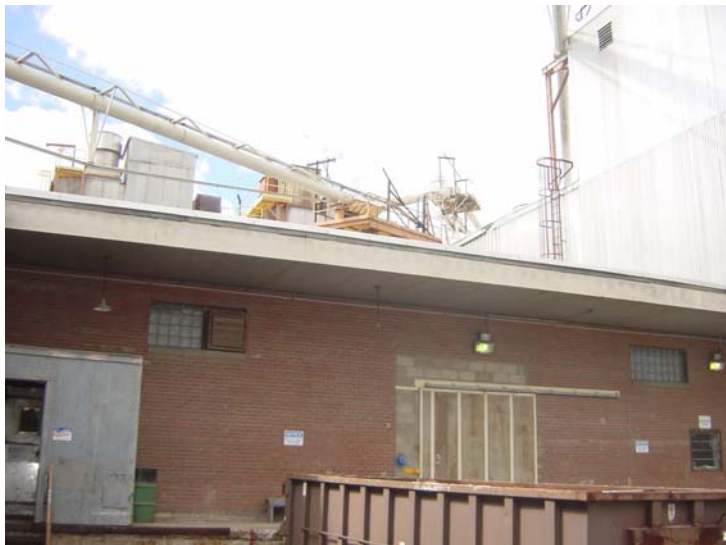
Burgess Storehouse Receiving Transite

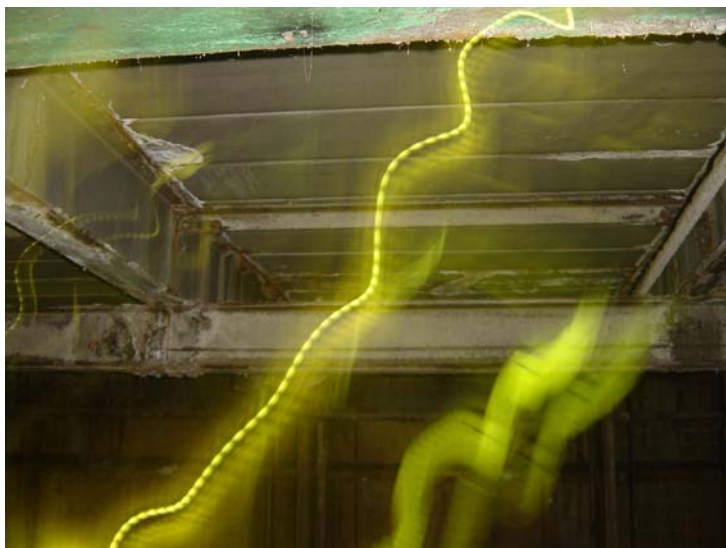
Evap Bldg 1 Ceiling Ceiling Deck

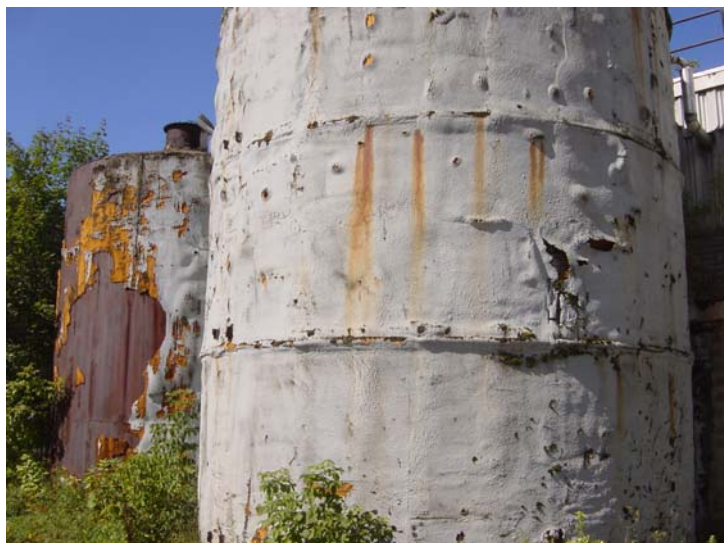
Tanks by Bleach - Pulp Storage, Samples B93, B94

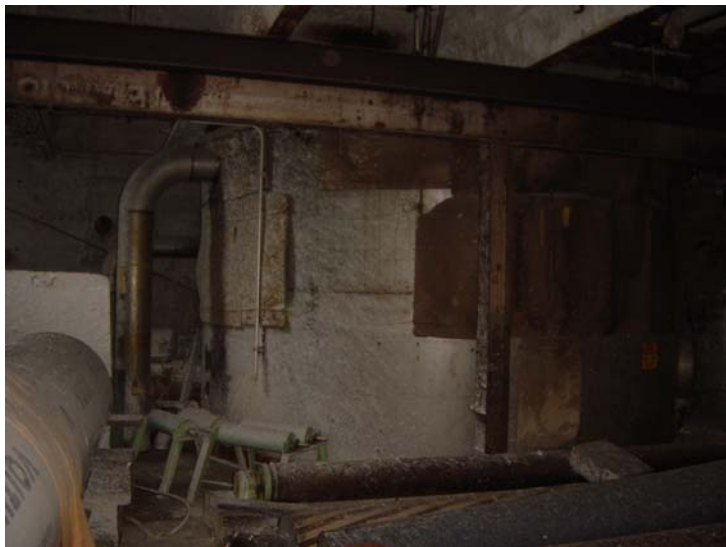
2 Dryer Basement Tank, Sample B047

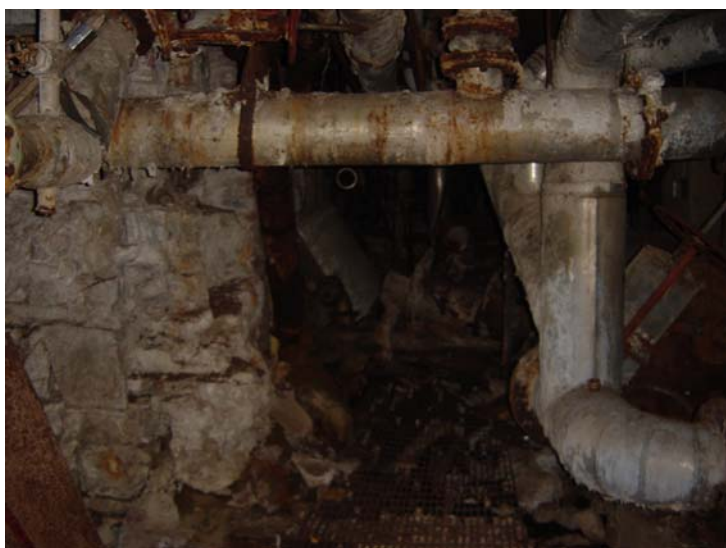
Basement Riverside Mill Storage, Debris Sample B083

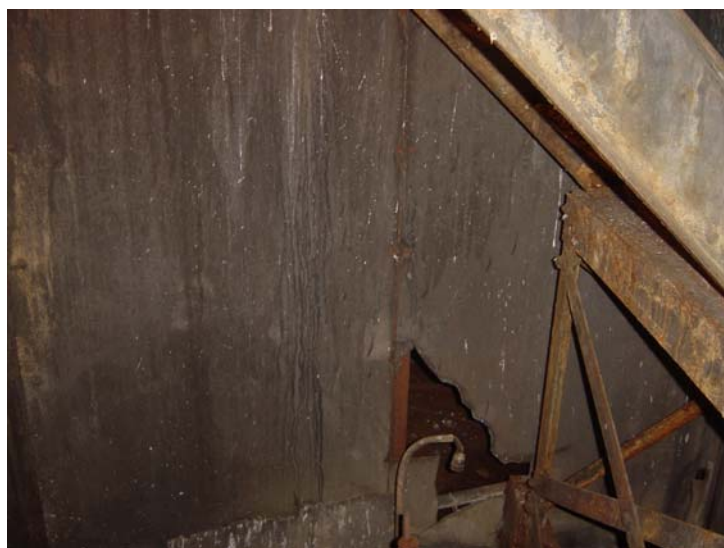
Boiler 7, top Level, Transite wall

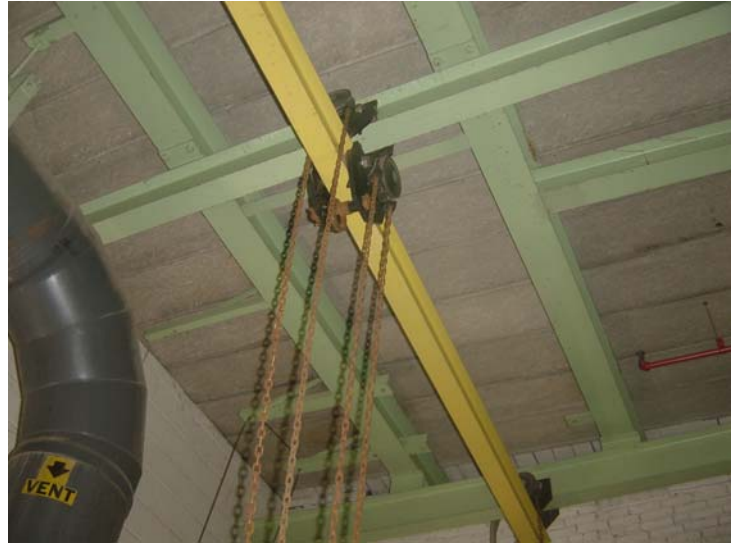
Cavity Decking

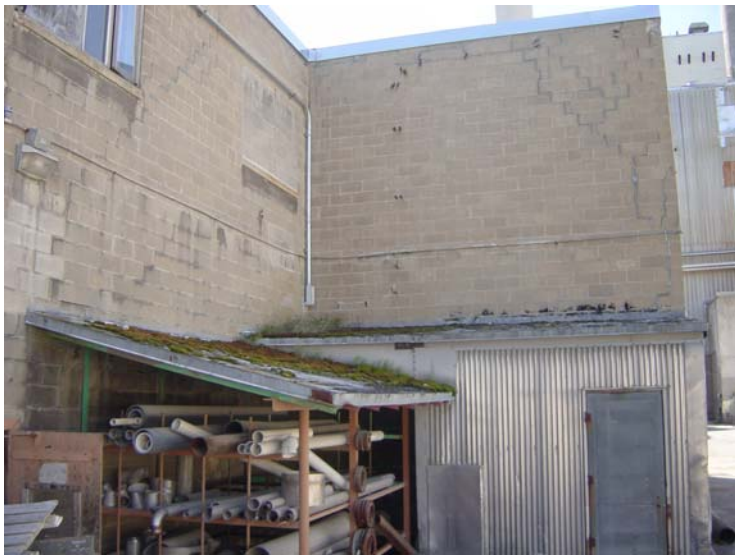
Central Shop Small Rear Roofs, Sample B086

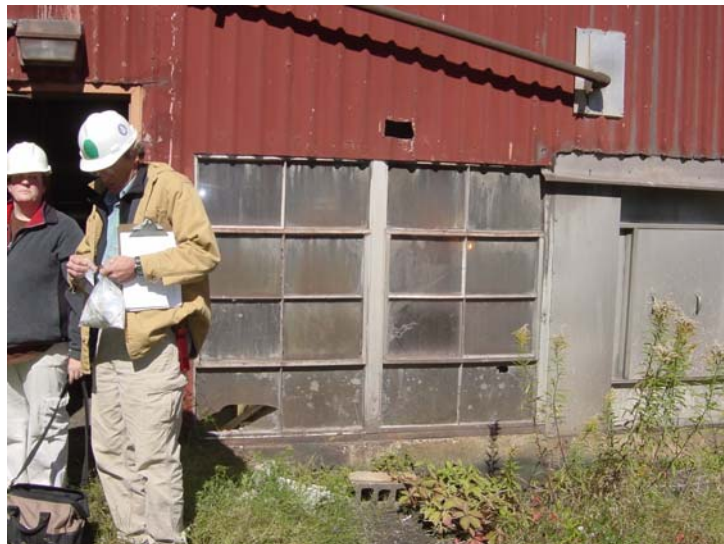
Central Steam, Boiler 9 Ext, Sample B037

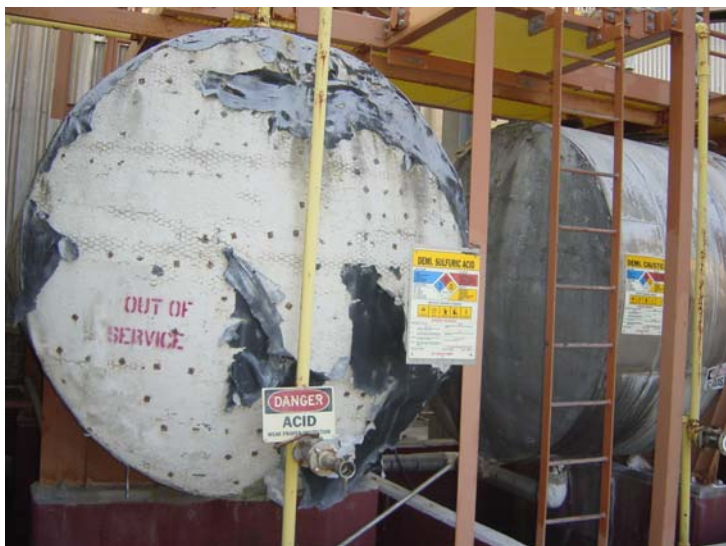
Demi Sulf Acid Tank by Demi Plant, Sample B95, B96

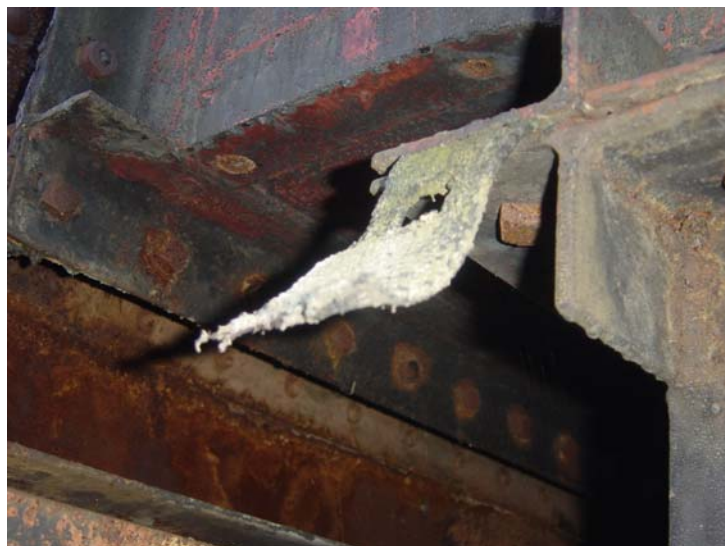
Duct Gasket Boiler 7 Roof, Sample B76

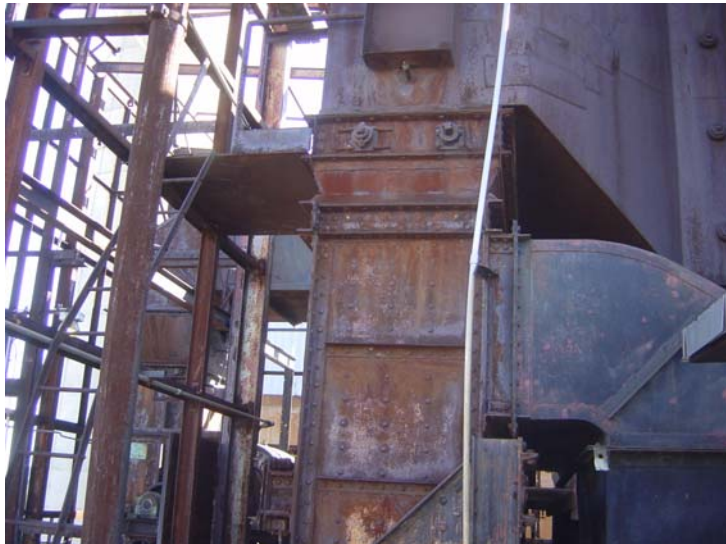
Duct w Gasket on roof boiler 7

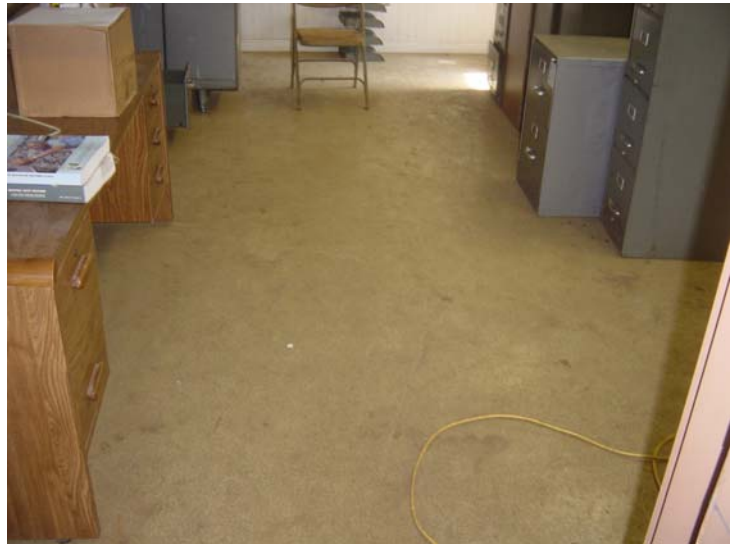
Riverside Mill Storage, 1st Floor Office Floor, Sample B024

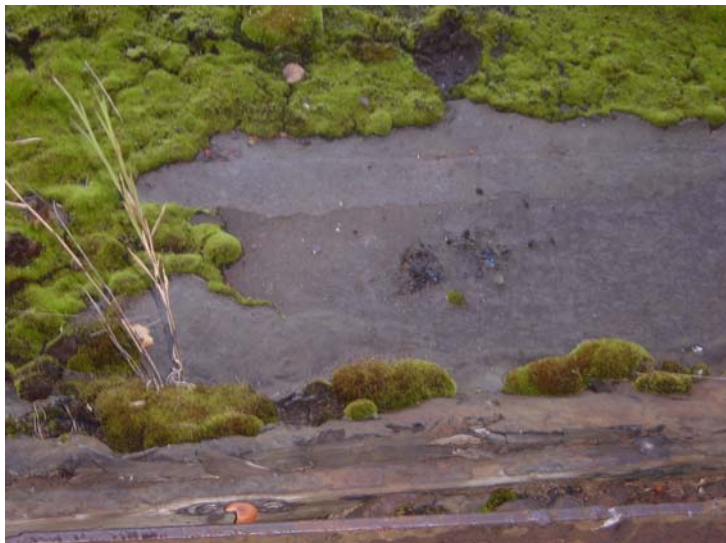
Roof Sample over Boiler 7, Sample B77

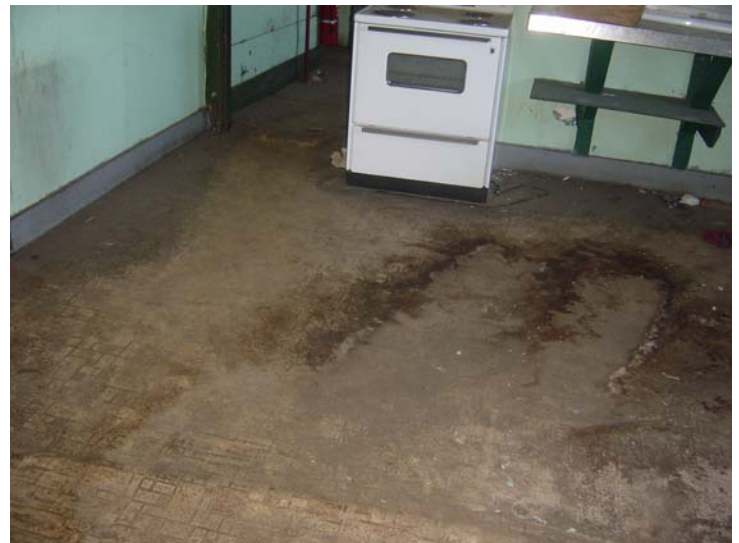
RR Shop 2nd Floor Lino Floor, Sample B036

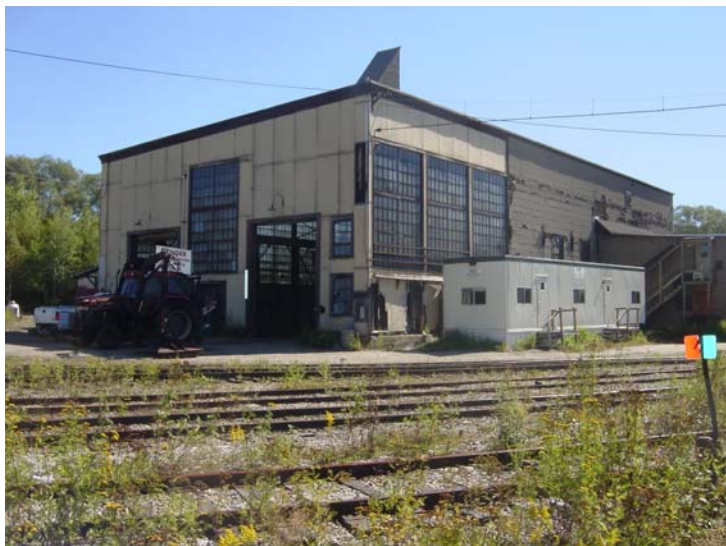
RR Shop Transite Siding

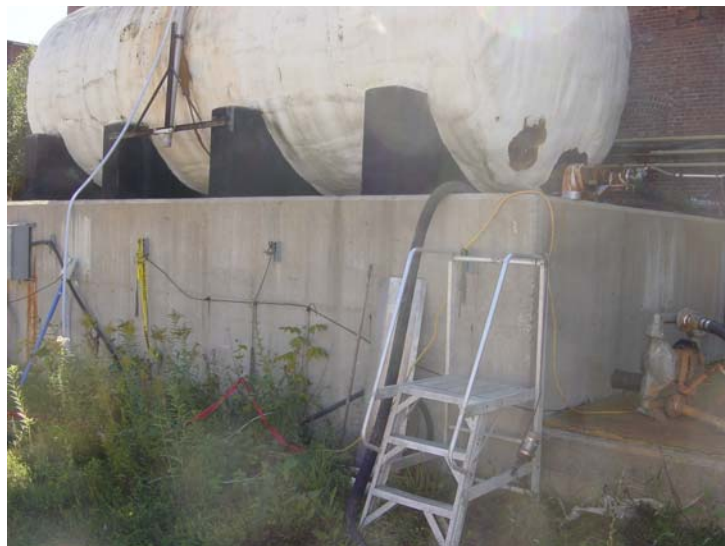
Sulfuric Acid Tank by Alpha Plant, Sample B053

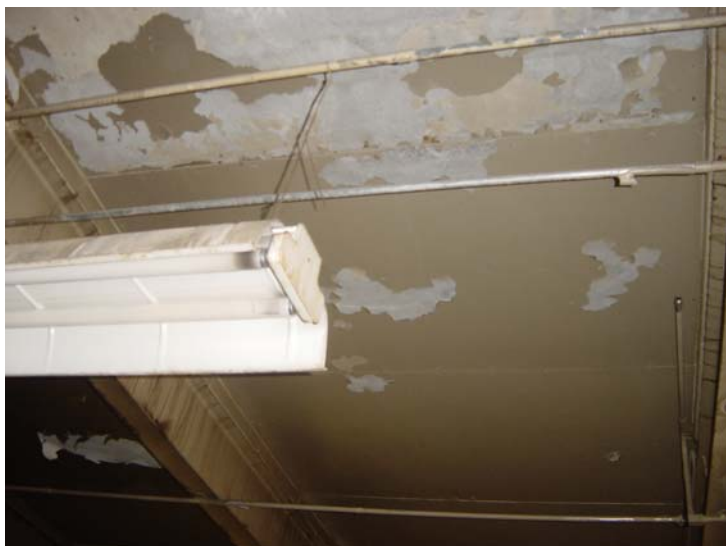
Transite ceiling, substation 4, central steam

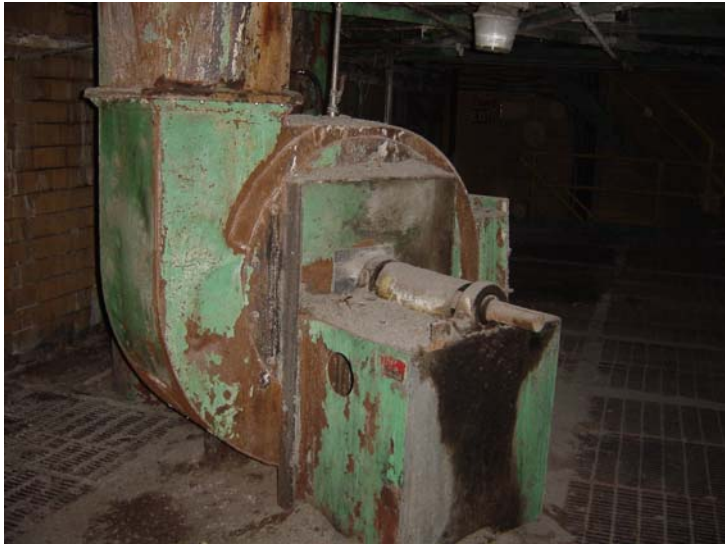
#8 Boiler Recover Unit, 5th Level Blower Duct Gasket, B121

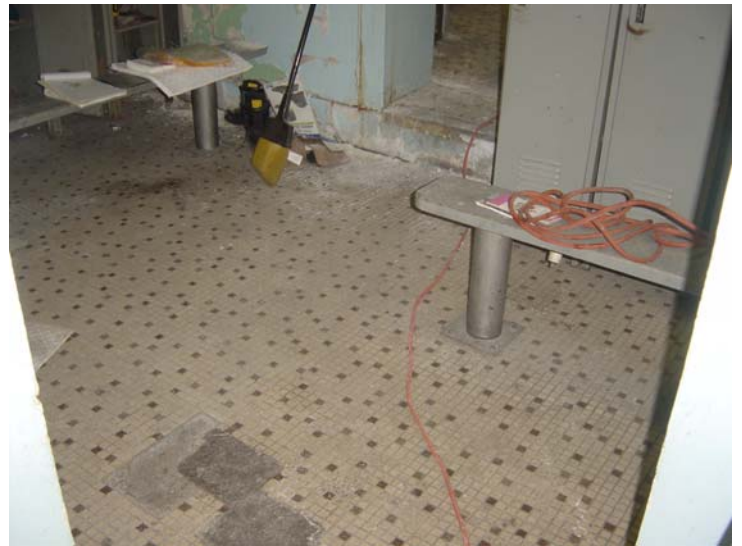
#8-#11 RCU Boiler - Locker Area #11 Flooring, B122, B123

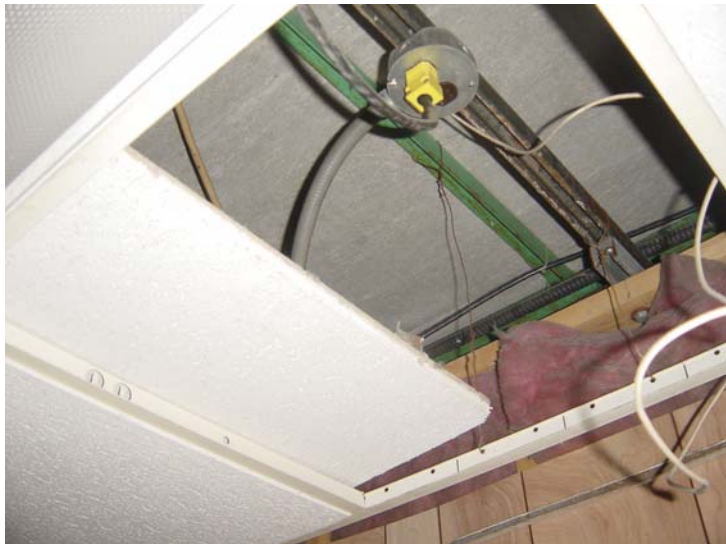
#8-#11 RCU Boiler - Locker Room Ceiling Transite

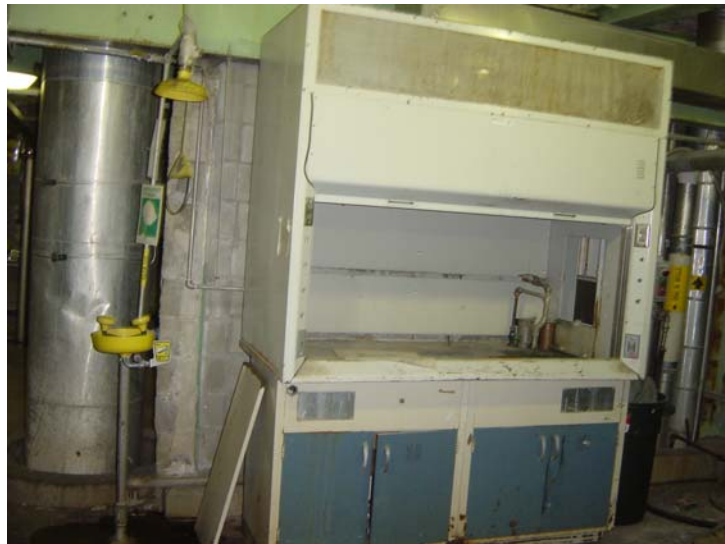
#11 Recover Boiler Unit, 3rd Level Fume Hood Lab Top, B126

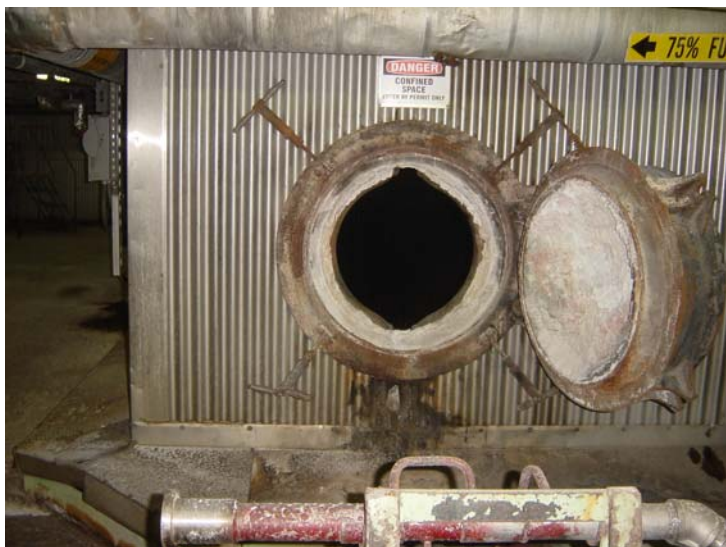
#11 Recovery Boiler Unit, 3rd Level Clean Out Hatch, B127

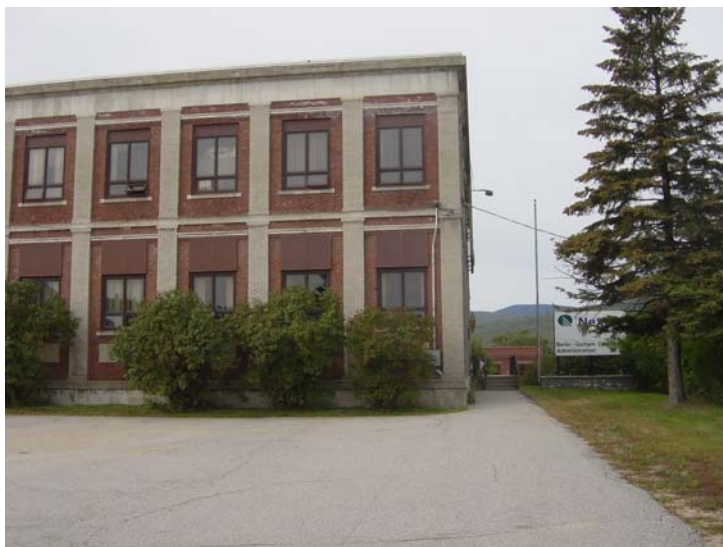
Admin Building Exterior, Window Caulk Sample B104

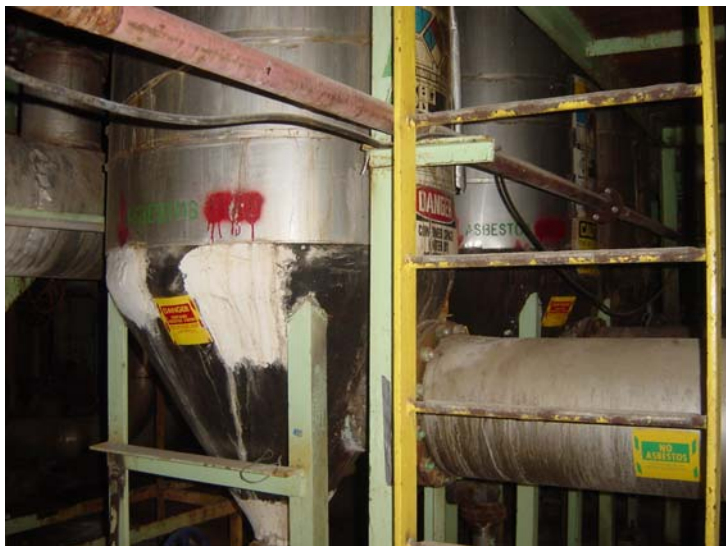
Blow Heat Recovery, Fiber Filter Contaminated Water Tank

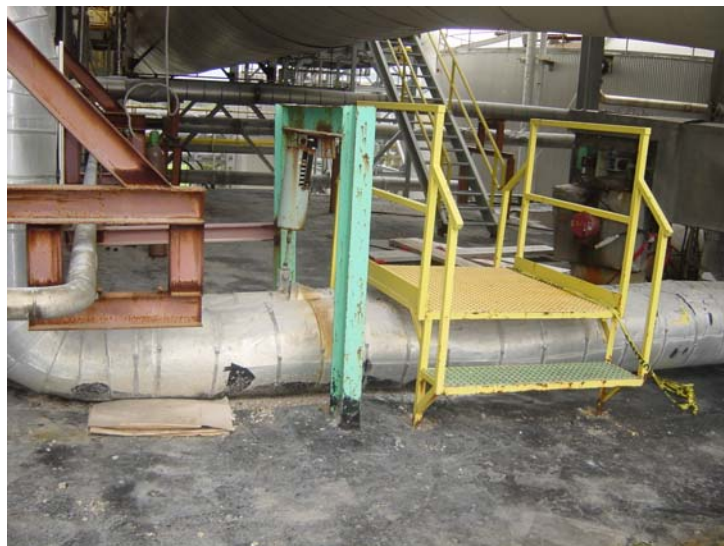
Demineralization Plant Roof, Sealant by Catwalk, Sample B125

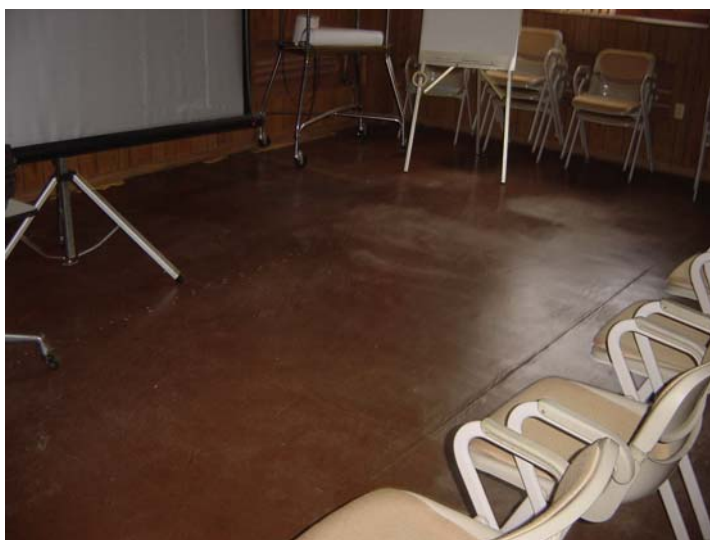
Industrial Relations, 2nd Floor Linoleum,  
Samples B108, B109

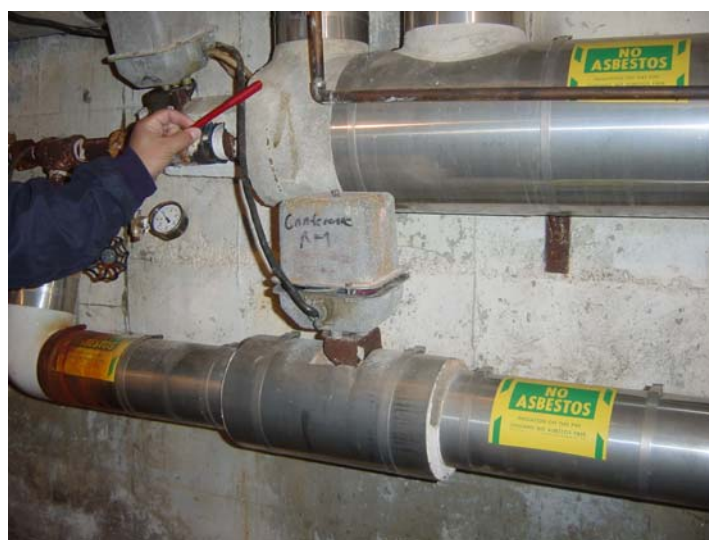
Industrial Relations, Basement Fitting Insulation,  
Sample B107

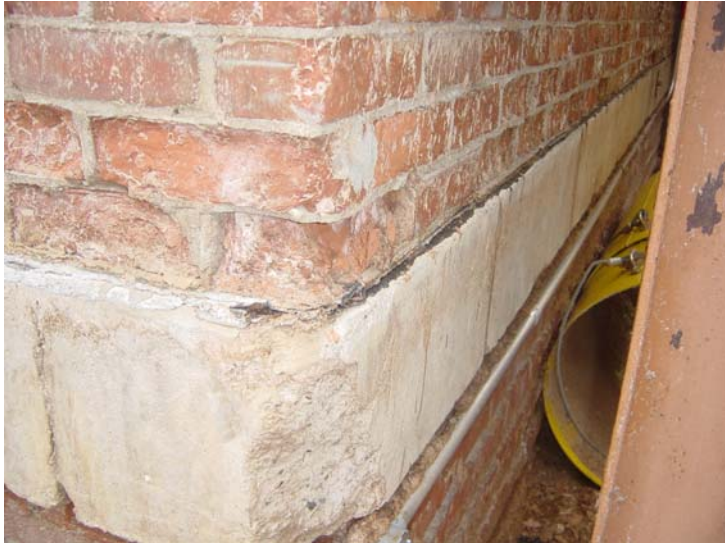
Kraft Digester Bldg, Outside Corner by Screen Bldg, Sample B128

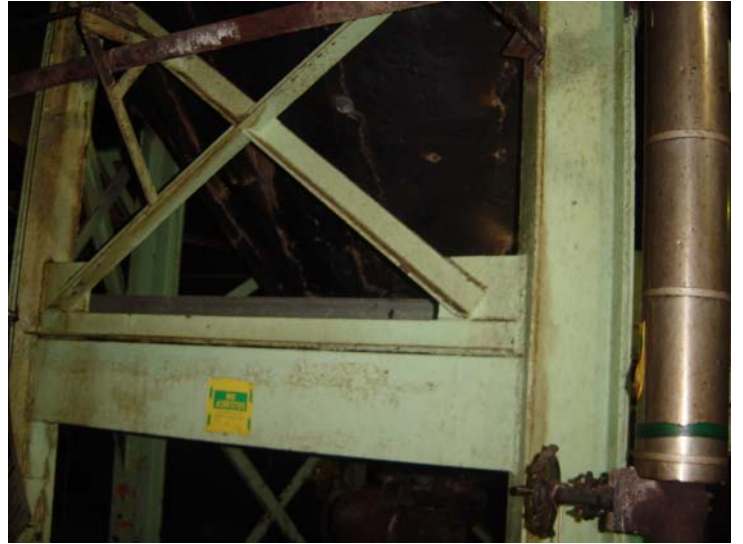
Kraft Digester House, Digester 1, Bottom Level, Sample B114

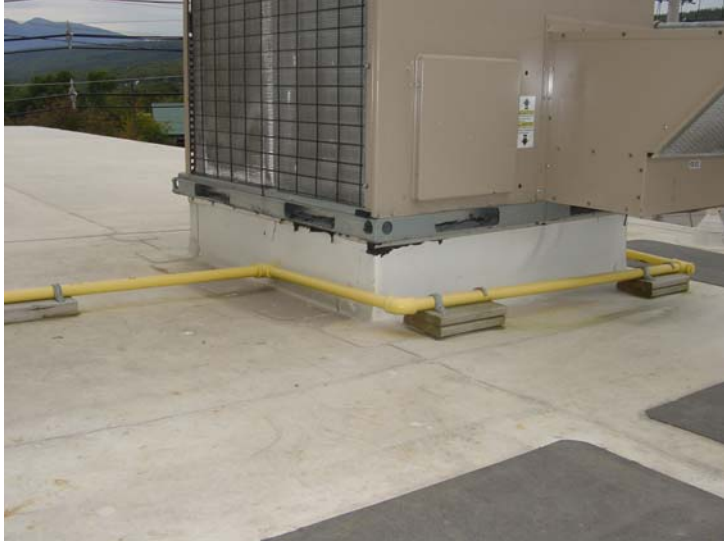
New Co-Gen Plant, Gasket Closeup, Sample B133

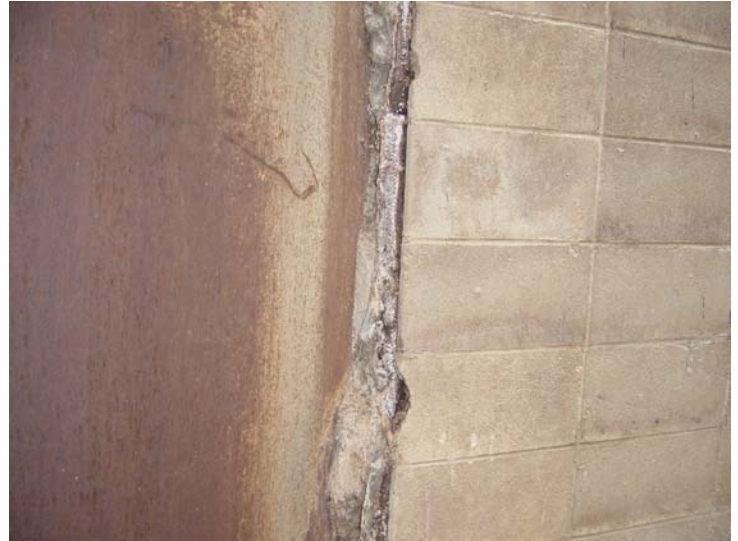
Old Softwood Catcher Tank, Inside First Level, Sample B110, B111

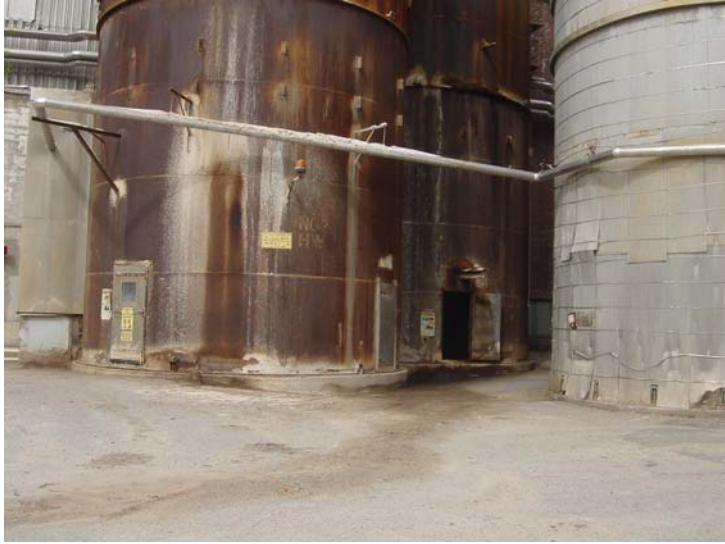
Old Softwood Catcher Tank, Insulation Remaining at Wall to Digester Bldg, Sample B132

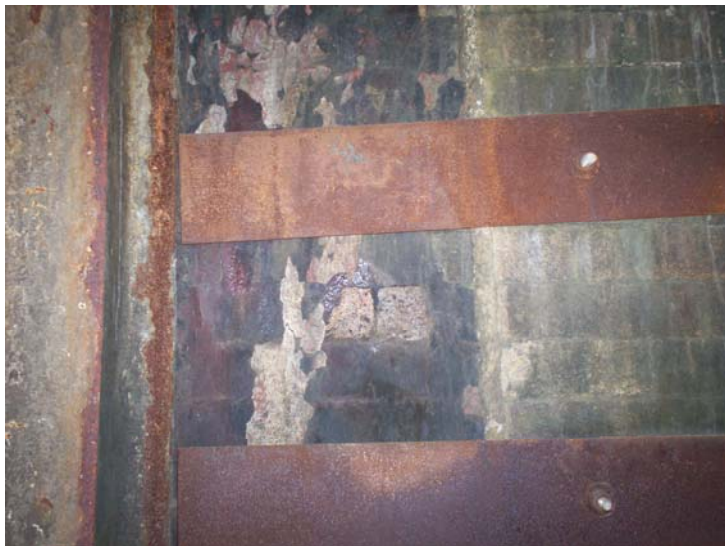
Central Steam Boiler #6 refractory packing, Sample B016

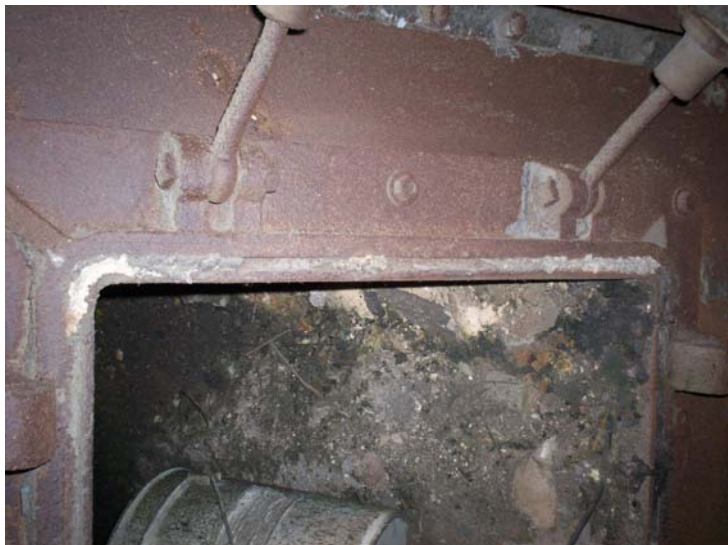
Central Steam Boiler #7 black paper on brick, Sample B012

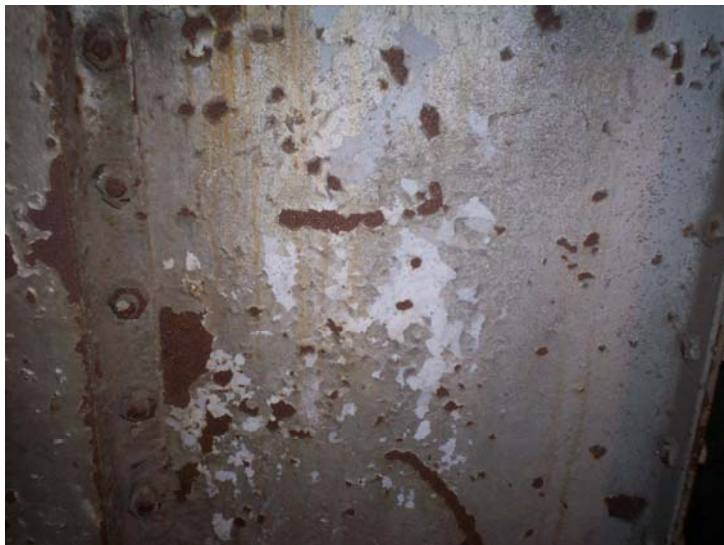
Central Steam Boiler #7 rope gasket, Sample B007

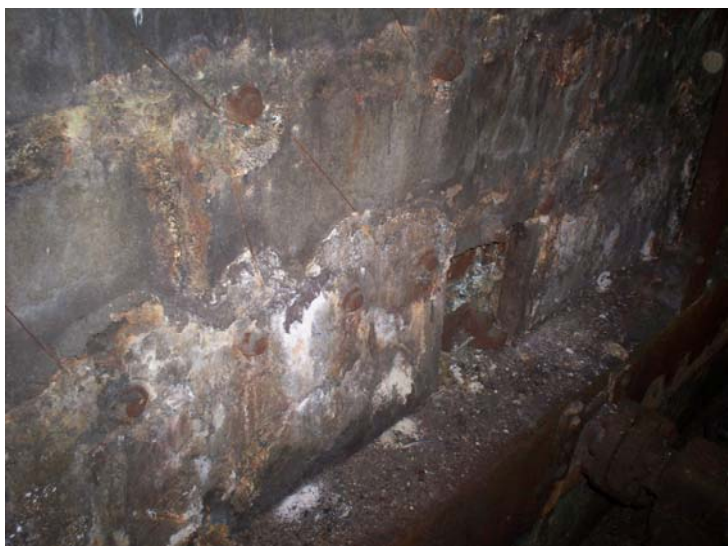
Central Steam Boiler #7 silver paint, Sample B008

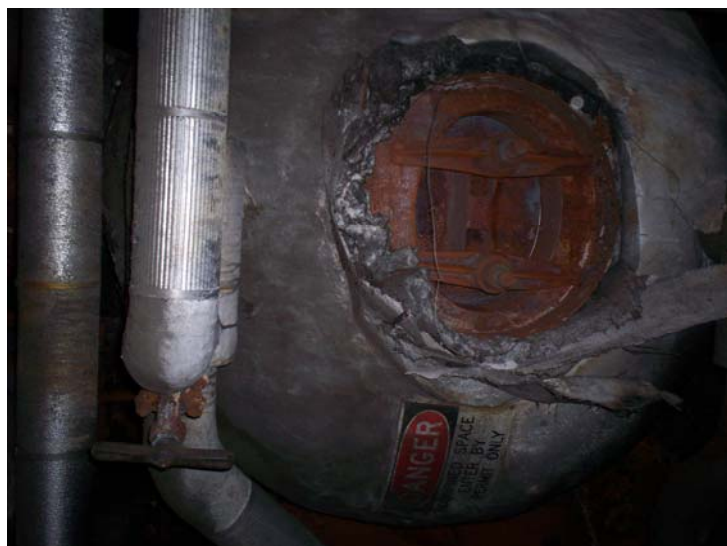
Central Steam Boiler #7 surface coating and black mortar

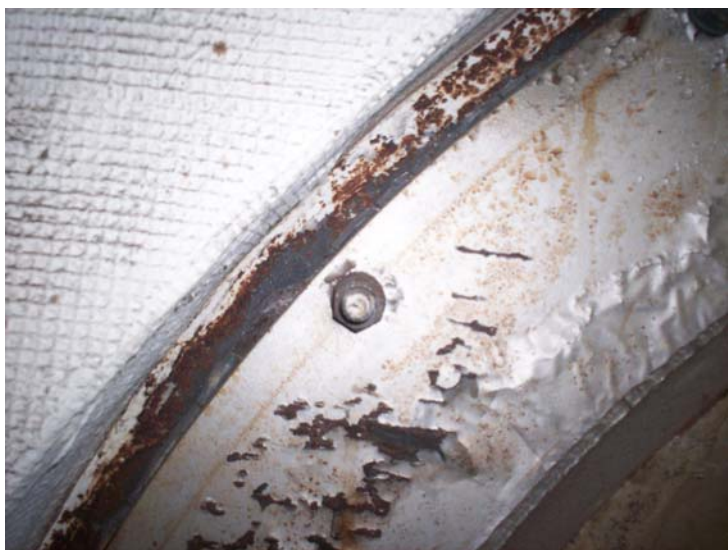
Central Steam Boiler #9 4 th level tank insulation (not sampled)

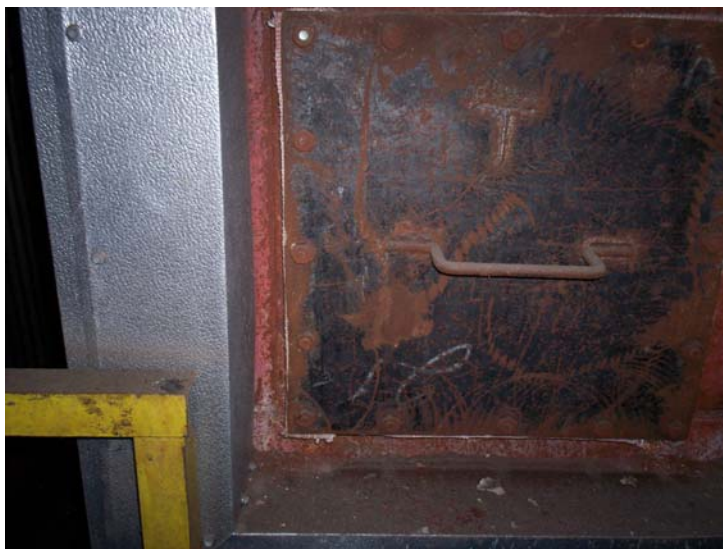
Central Steam Boiler #9 debris 4th level,

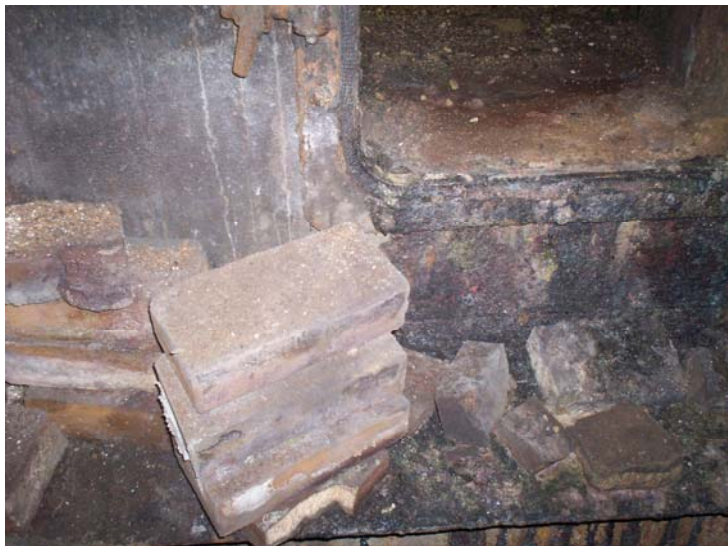
Central Steam Boiler #9 packing material, Sample B001

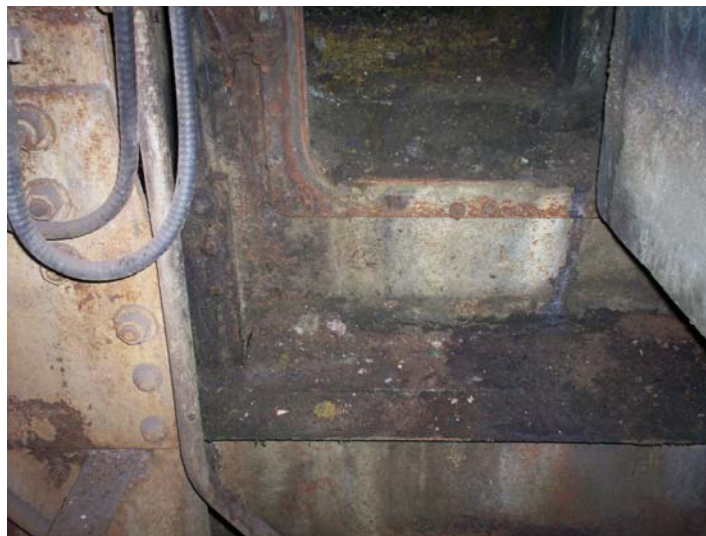
Central Steam Boiler #9 refractory brick

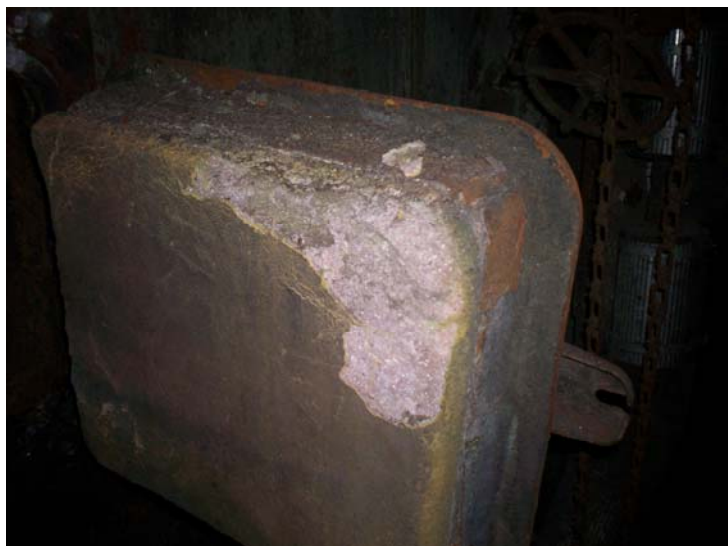
Central Steam Boiler #9 refractory cement

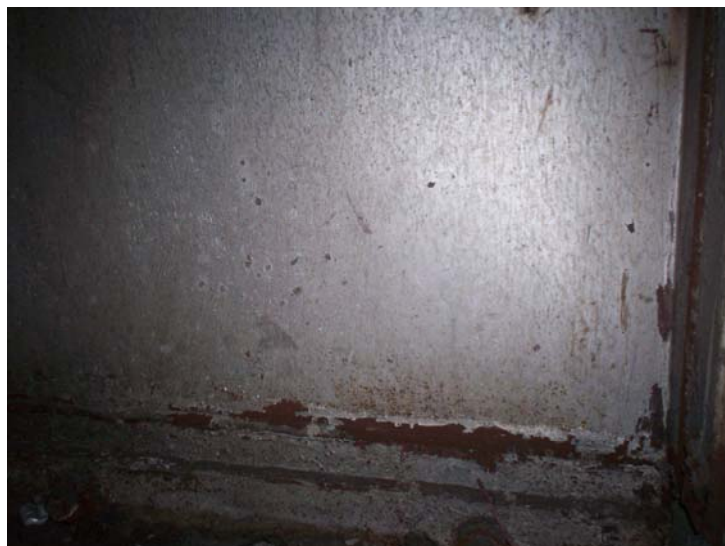
Central Steam Boiler #9 refractory cement on access door, Sample B002

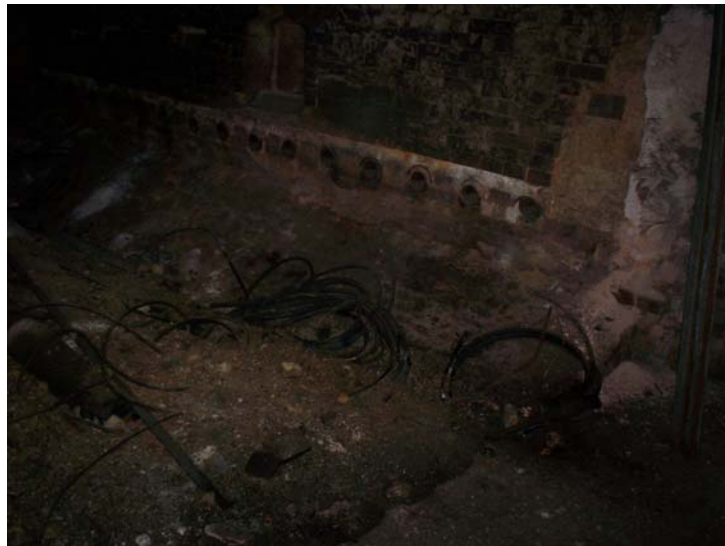
Central Steam Boiler #9 tank insulation damaged (not sampled)

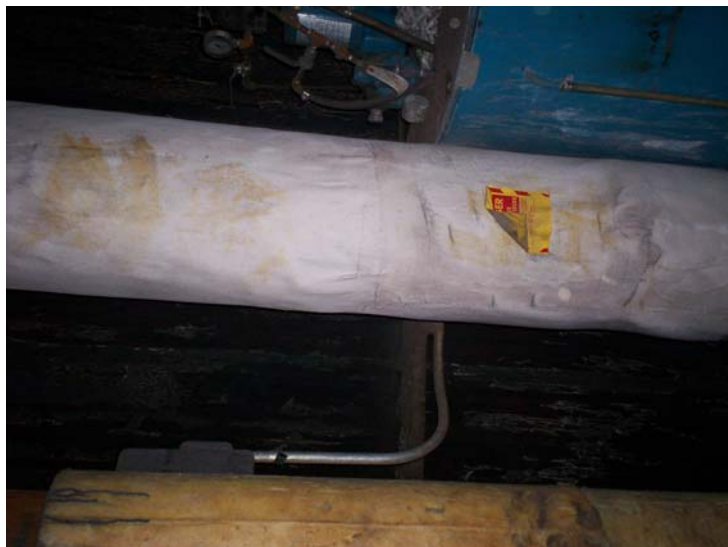
Central Steam, Boiler #6 sample B020

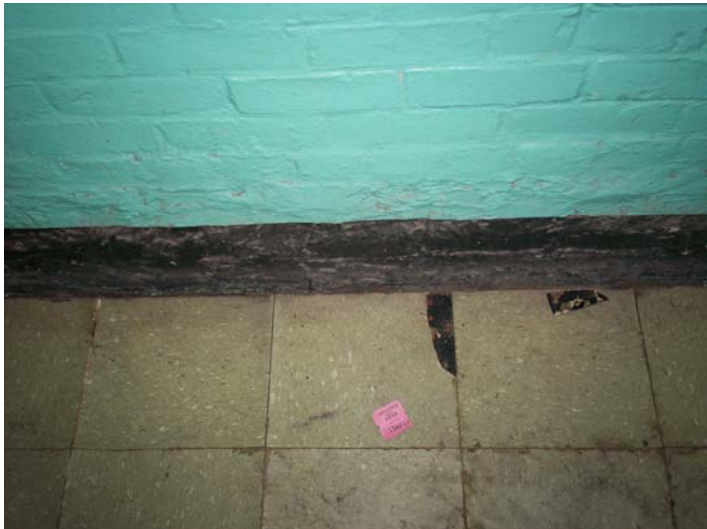
Central Steam, Control room flooring by Boiler #7, Sample B014

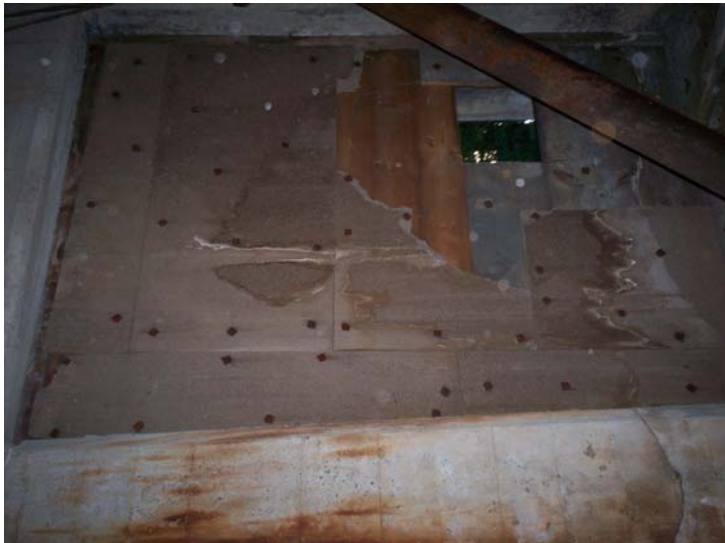
Ext. duct outside Boiler #9, Sample B023 was taken approximately 30' down the duct. It's possible that other suspect material is present in various areas of the duct

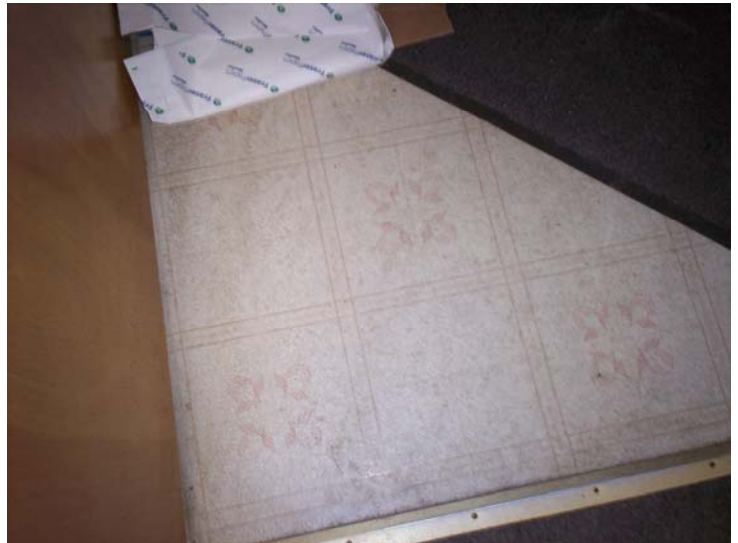
Fiber board Riverside mill, Sample B029

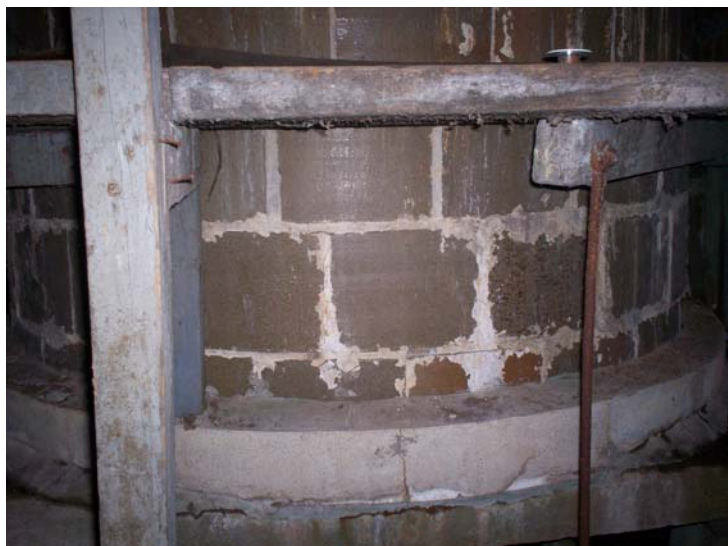
Riverside Mill basement patch

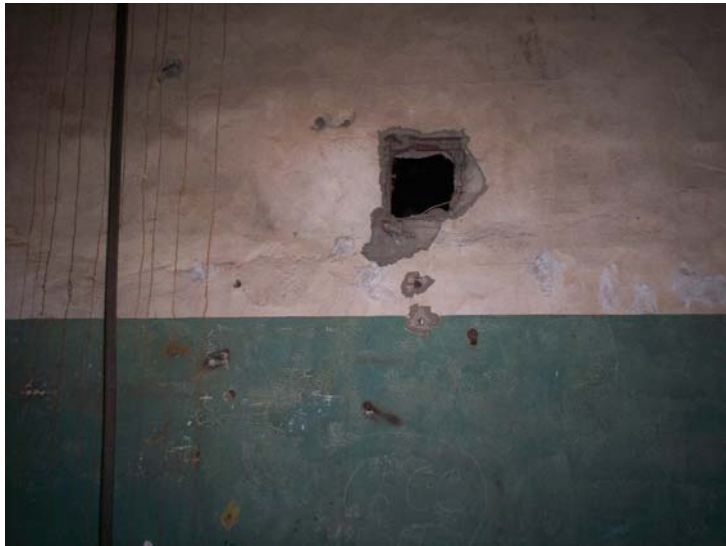
Riverside mill Plaster, Sample B027

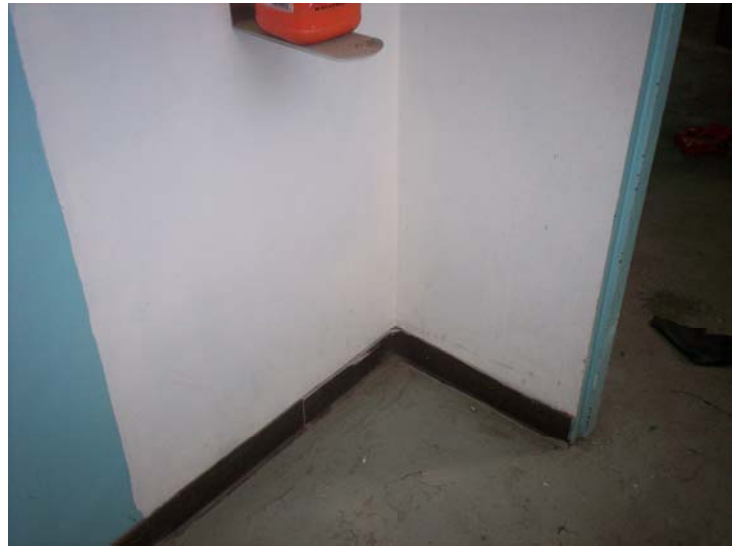
Riverside mill, Plaster Wall, Sample B026
